## Minerals Inspection Report

Mine Name: H&B Mine	Permit Number: S/019/0063	Mine Status: Active
Operator Name: Red Cliff Mining, Inc.	Inspection Date: 05/18/2015	Permit Fees: Paid
Inspector(s): M. Bradley	Inspection Time: 5:05pm	Bond Amount: \$13,000
Attendee(s): Solo	Weather: Cloudy, T-storms	Bond Escalation: 01/11/2019
Inspection Purpose: Routine inspection		Prior Inspection: 08/25/2014

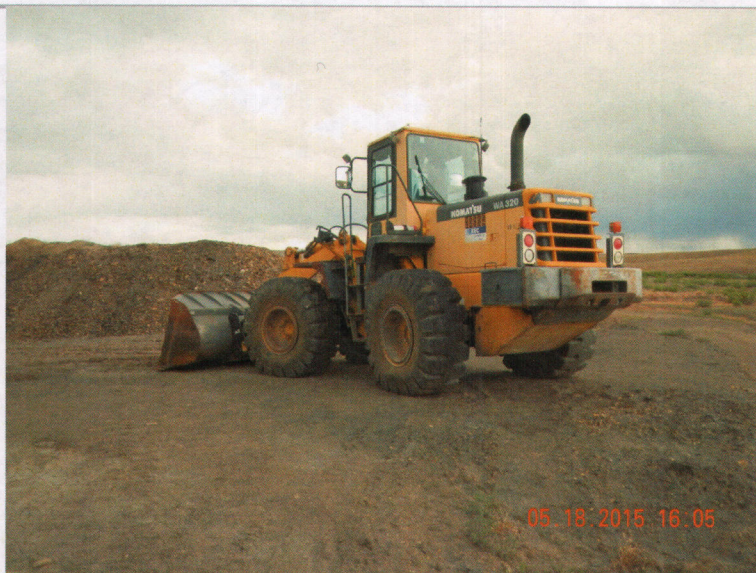
Location: 605293.00 m E, 4306311.00 m N, UTM 12S. Routine inspection while in the area. Loader was on site indicating that operations had resumed. No expansion beyond currently bonded area. No significant erosion problems evident. Road into site has degraded a bit, could use some maintenance. Site appears to be well maintained with regards to trash and debris. Inspection was cut short due to nearby lightning. NOTE: Time stamp on photographs was set at MST rather than MDT.

Loader on site

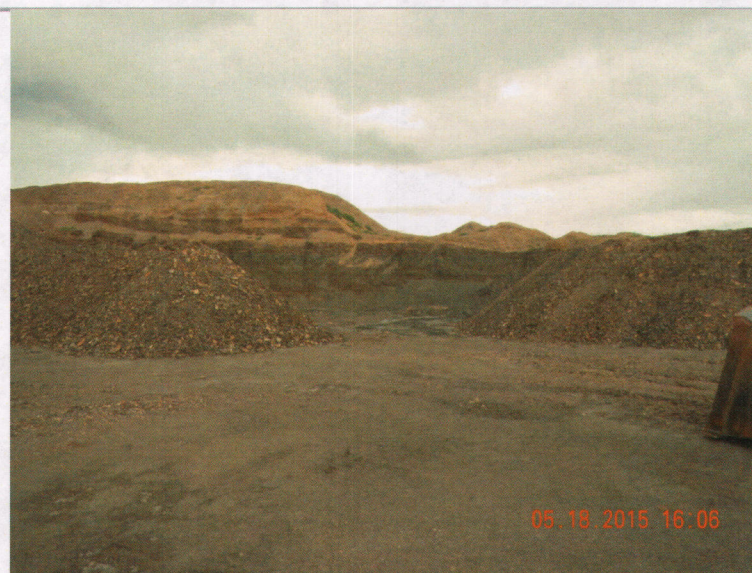
6. <i>Reclamation</i>	<input type="checkbox"/>	<input type="checkbox"/>
7. <i>Backfilling/Grading (trenches, pits, roads, highwalls, shafts)</i> Excavation has steep walls, but not high enough for significant concern	<input checked="" type="checkbox"/>	<input type="checkbox"/>

Excavation looking east

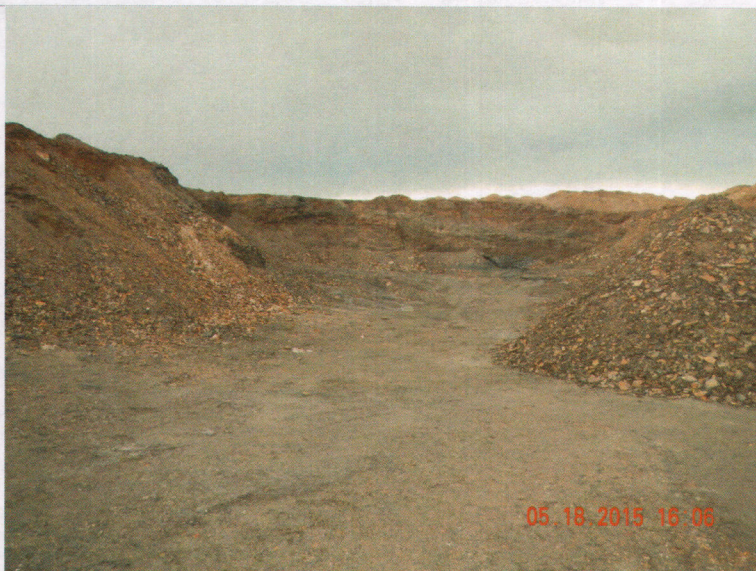
Excavation looking NE

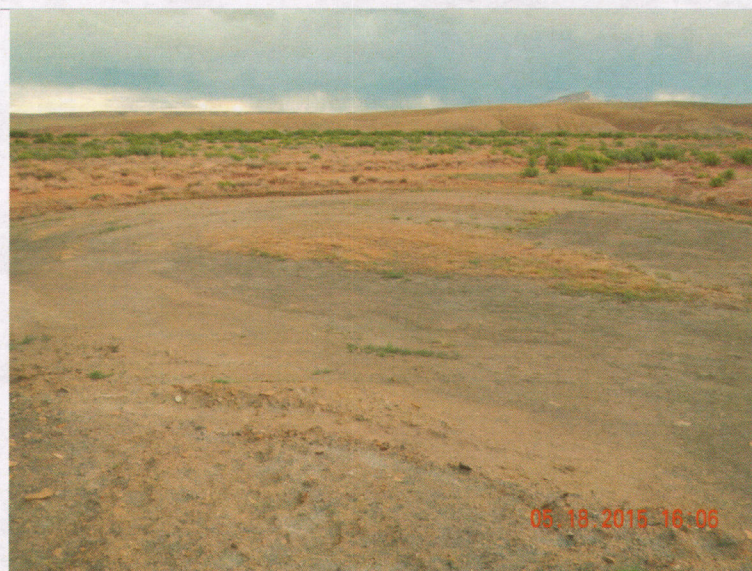
Truck turn-around area
